Combined FIB/EBAC Methods for Failure Analysis on Integrated Circuits

European CrossBeam® User Meeting Stuttgart, 15/16th May 2012

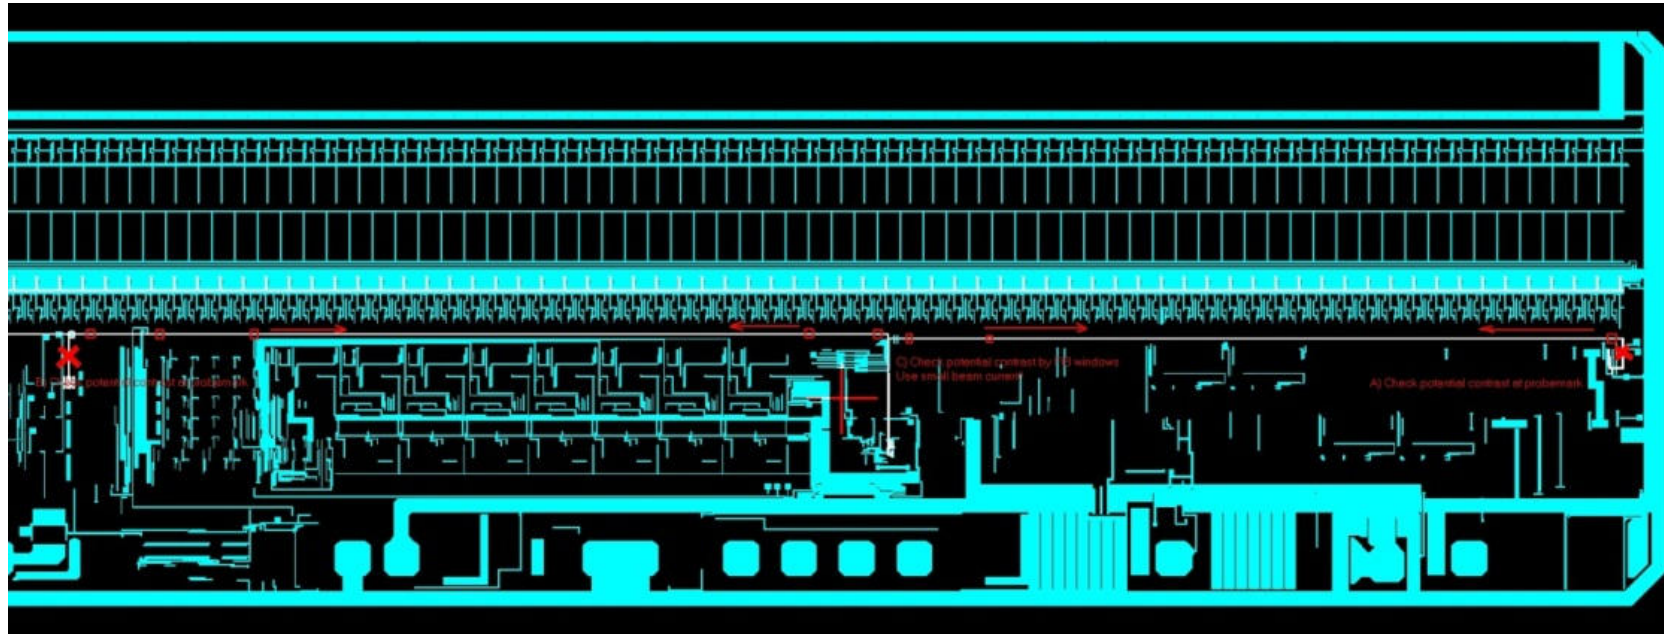
- Long metallisation network with high ohmic resistance
- Defect healing during PEM and OBIRCH analysis -> defect could not be localised
- EBAC at very low dissipation power (nW range) to avoid defect healing

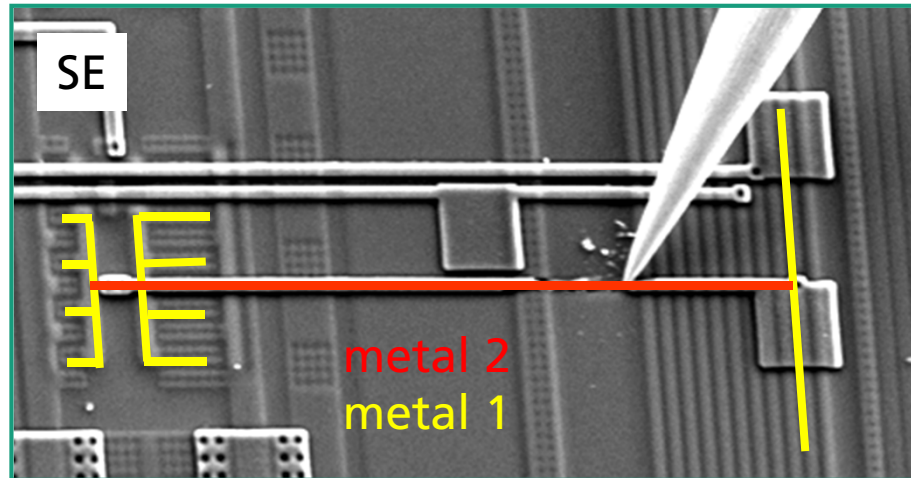
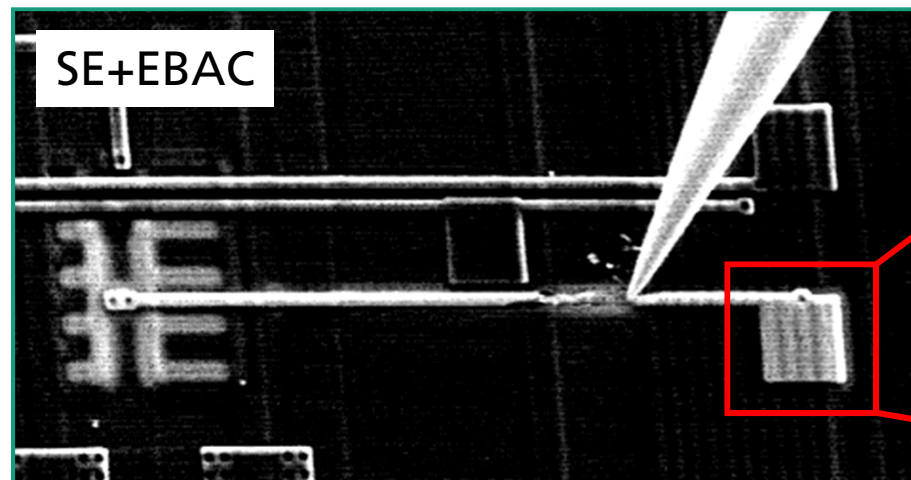
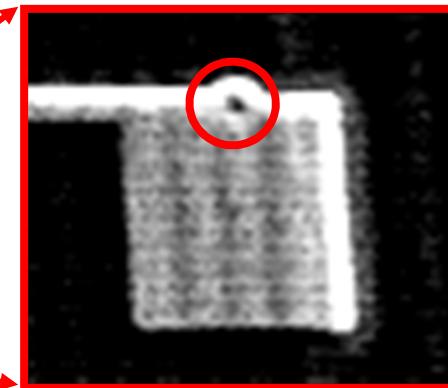
- Primary electron energy of 15 kV to reach both metal levels
 - Missing metal 1 (yellow) on right side
- > **open via to metal 1**

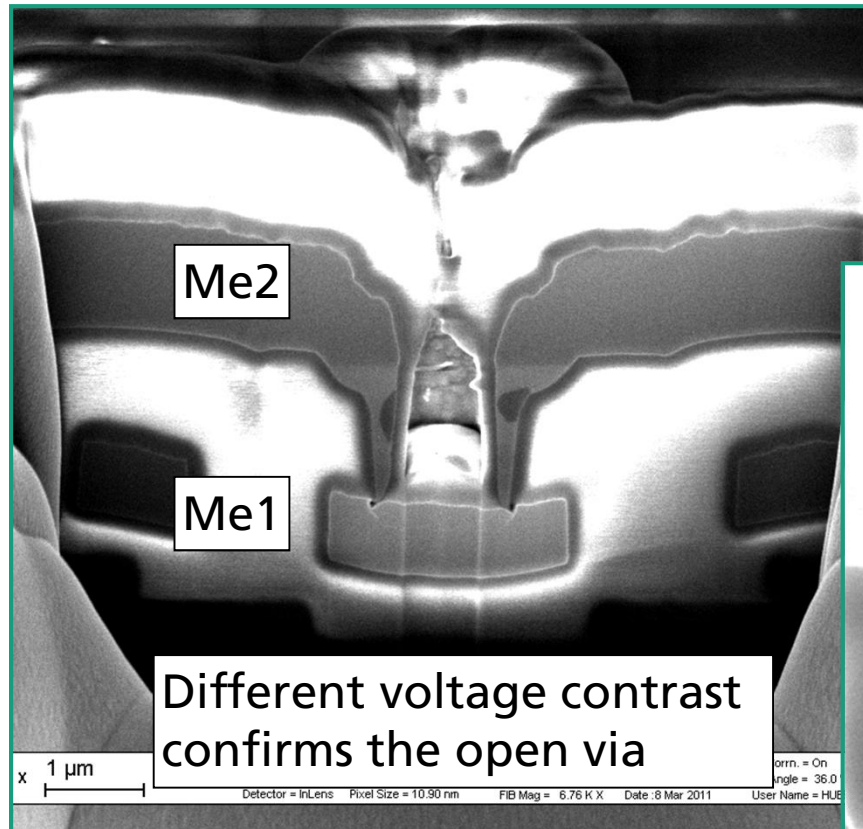
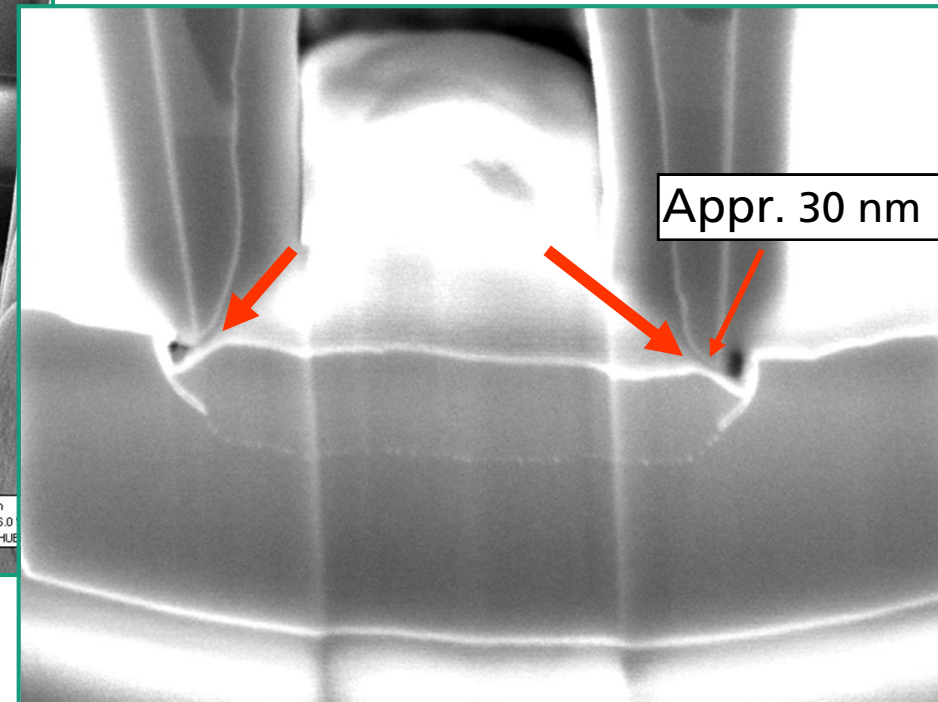
- Only thin spikes in contact with metal 1 -> local high resistance
- Low dissipation power (nW range) preserved original defect

Root cause:

deep + under etch in metal 1

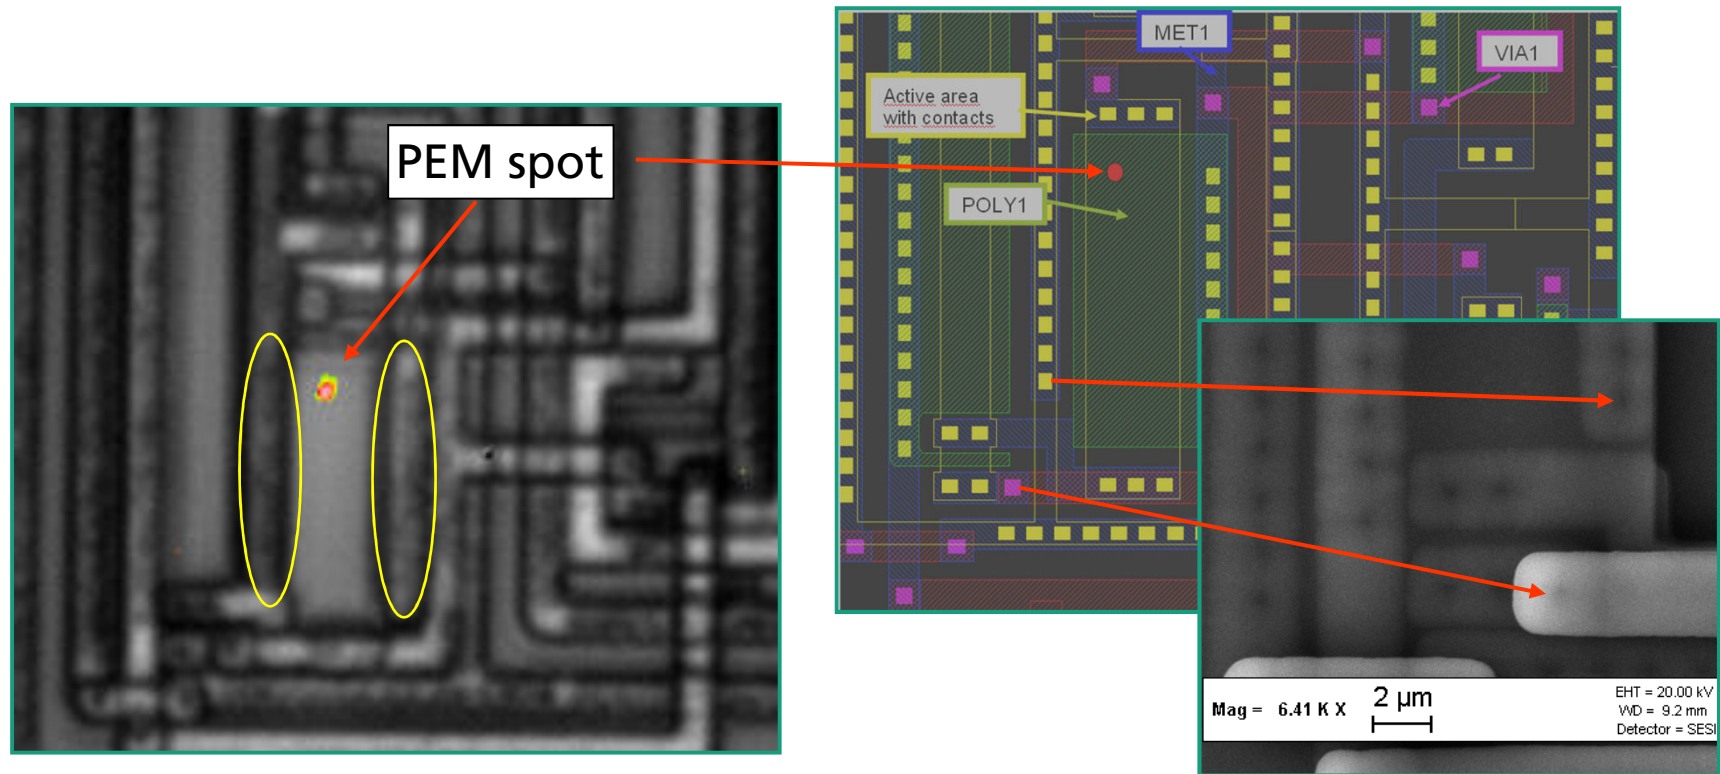
- Transistor gate shorted to substrate
 - Short localisation by PEM, but alignment to IC structure was insufficient for further TEM analysis
- > EBAC localisation

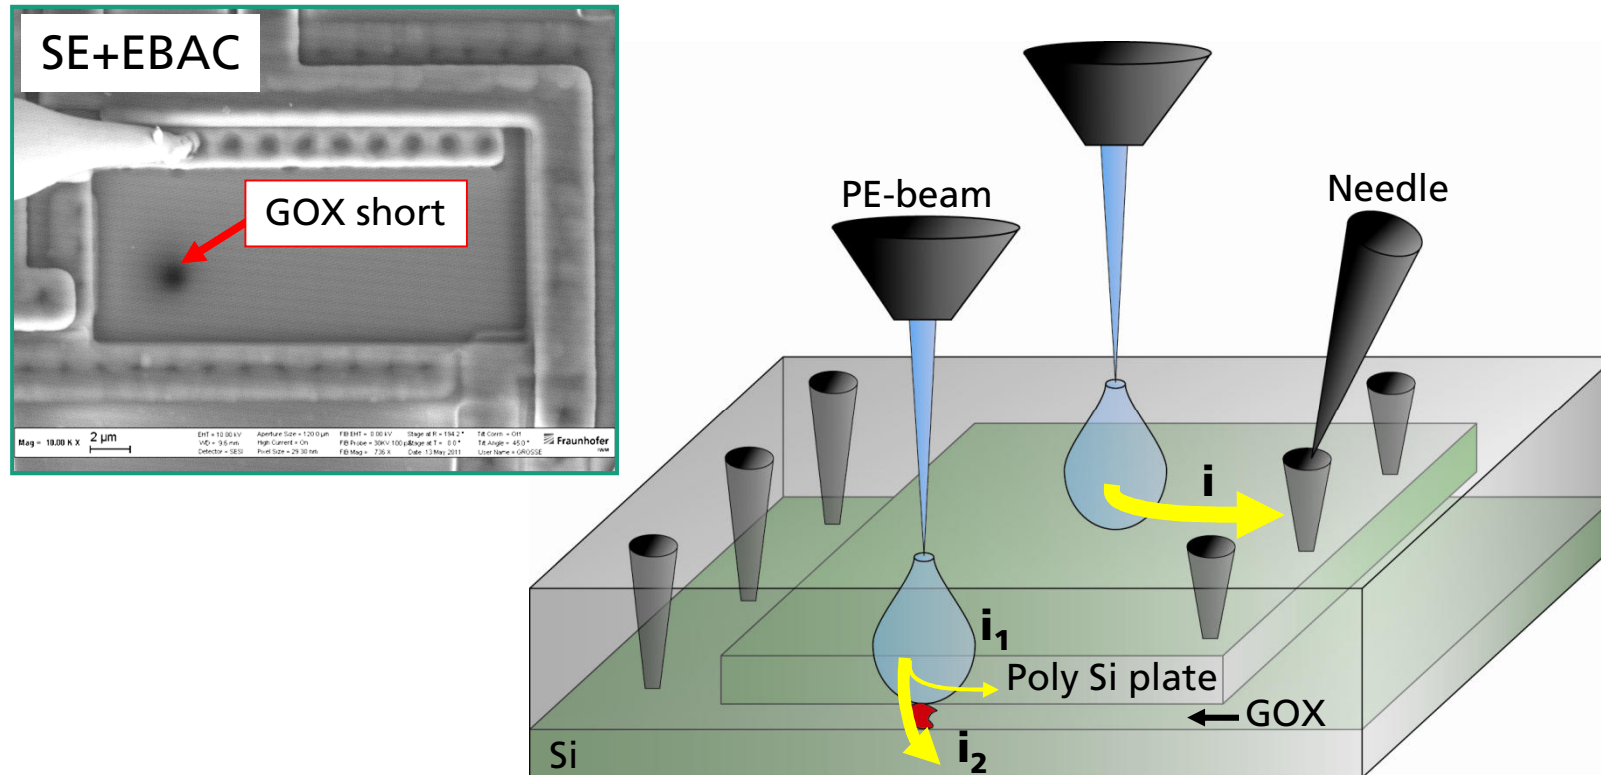
- Primary electrons reach the poly Si plate at suitable primary energy
- Current divider is active at GOX short, EBAC current flows to substrate
-> locally reduced EBAC current at defect site measured by needle

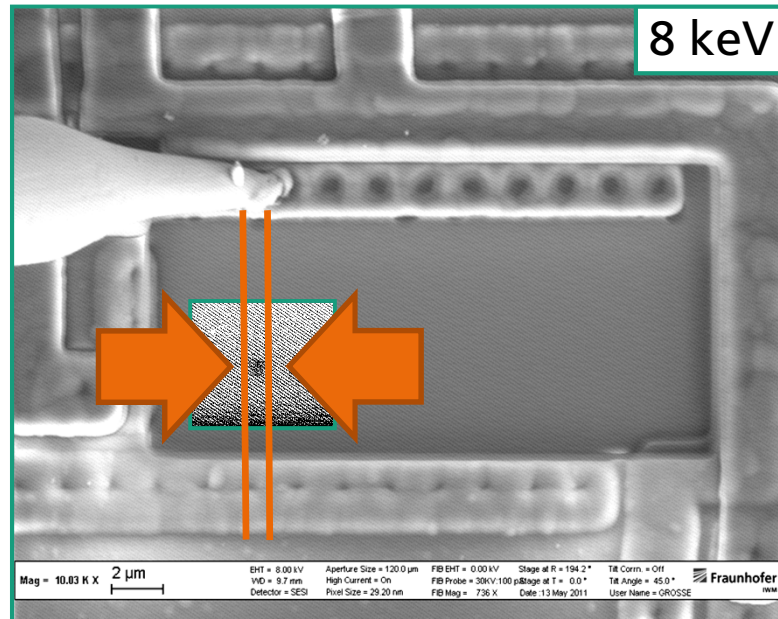
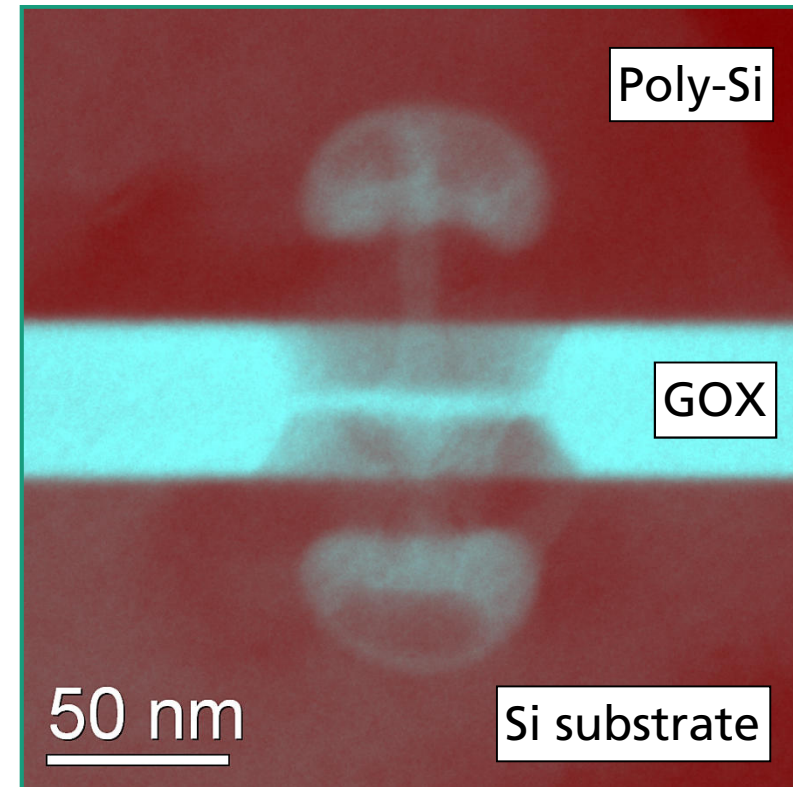
Localised defect size for FIB cross sectioning

GOX defect imaged by EFTEM

Root cause: ESD damage of GOX

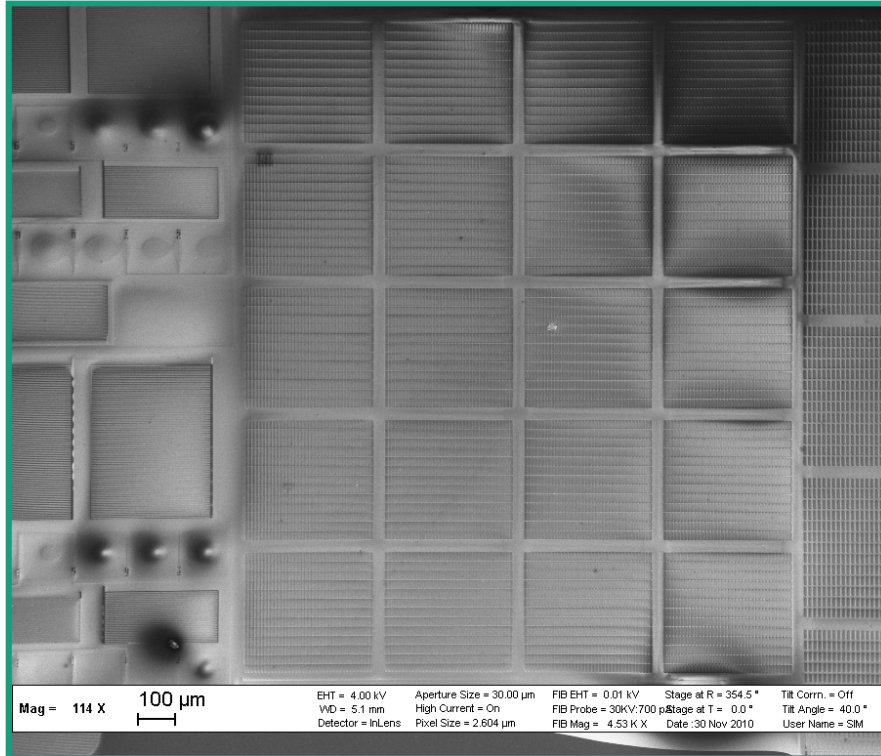
- The whole capacitor has a leakage to the substrate
- Capacitor consists of 20 modules with 13 columns and 38 rows each, makes 9880 overall single capacitors
- How to localize the defect?

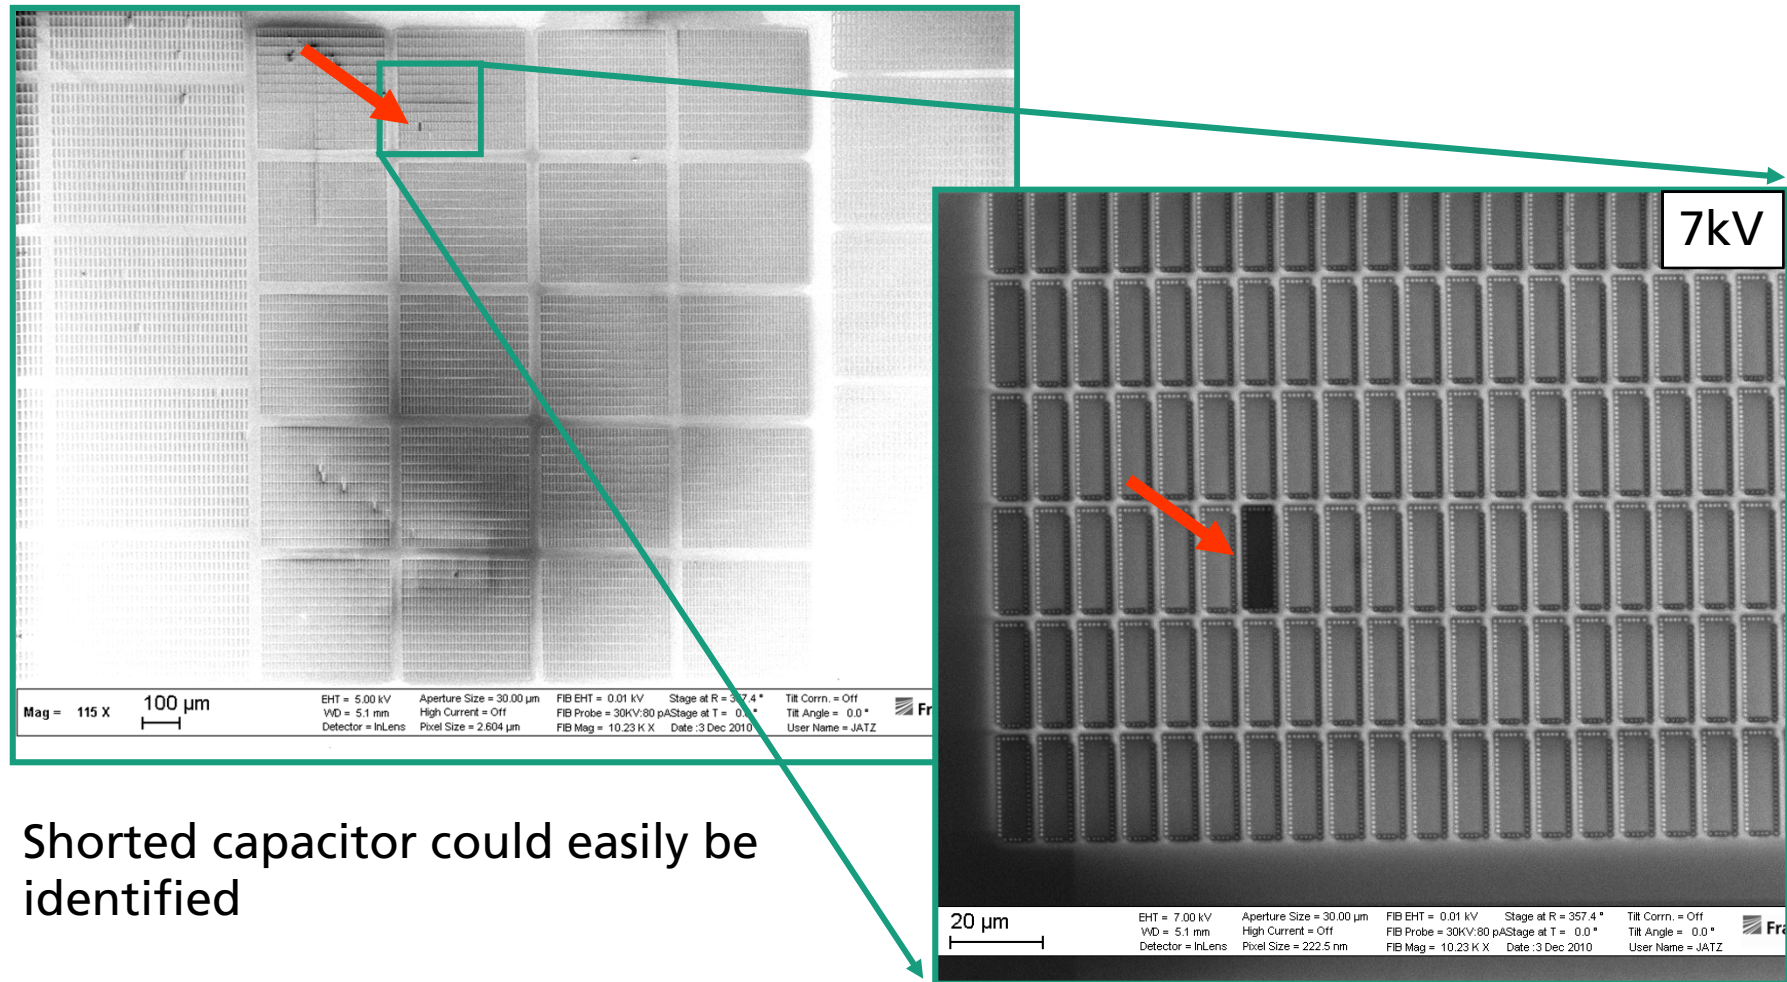
Shorted capacitor could easily be identified

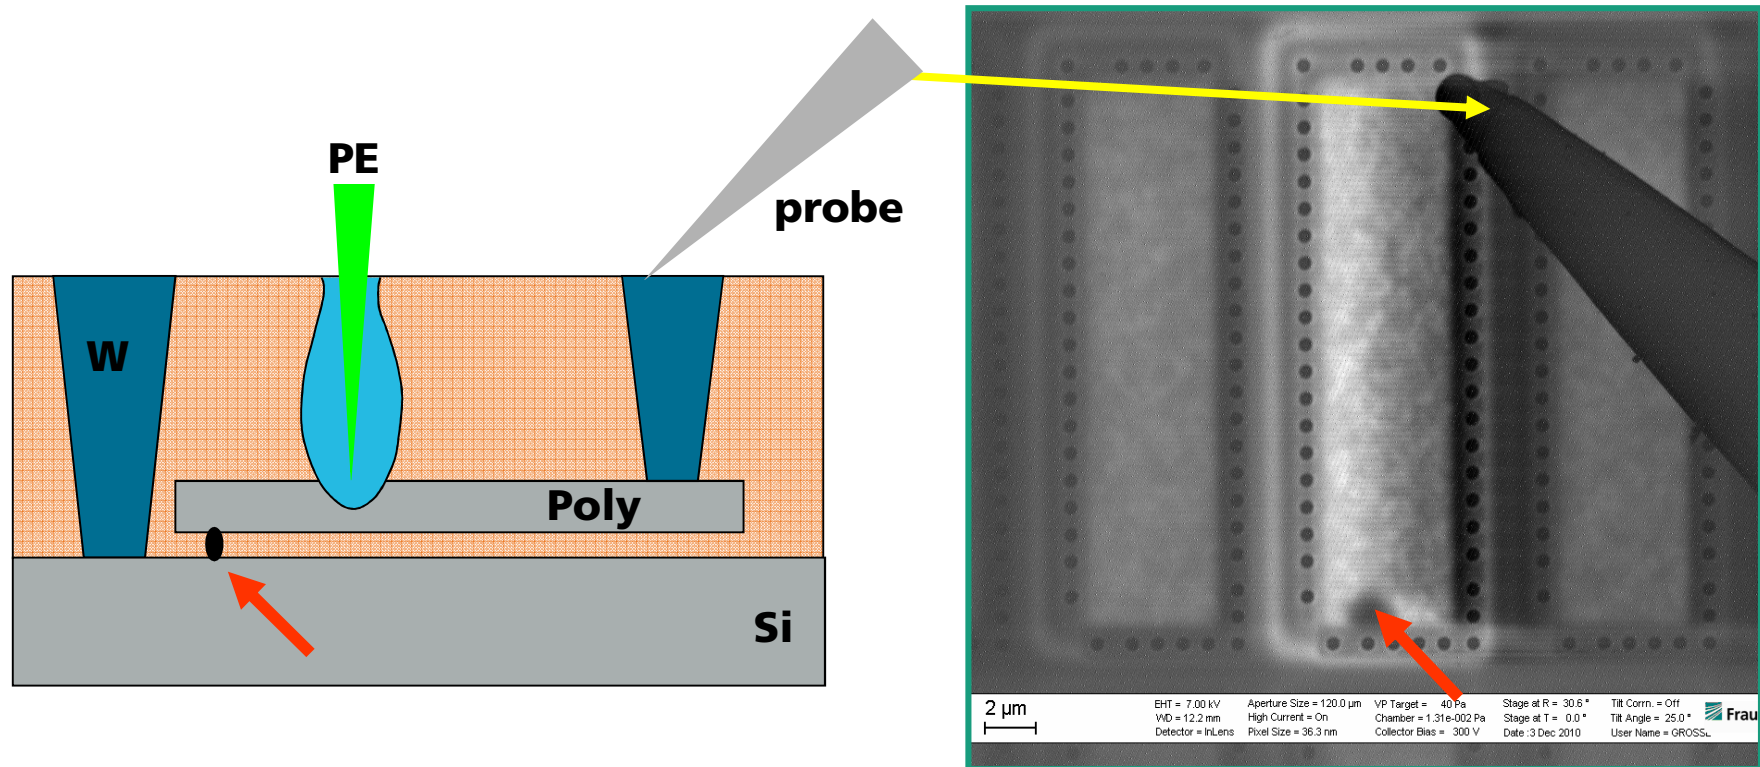
Short in capacitor oxide is localized with sub-µm precision

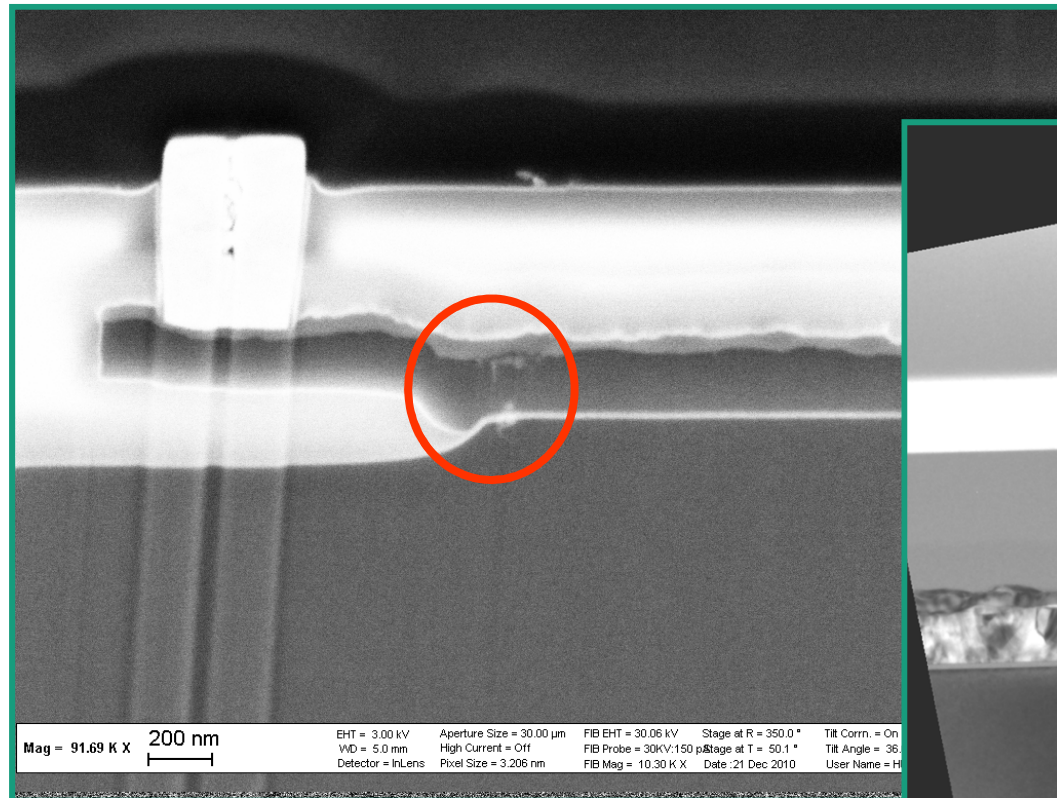
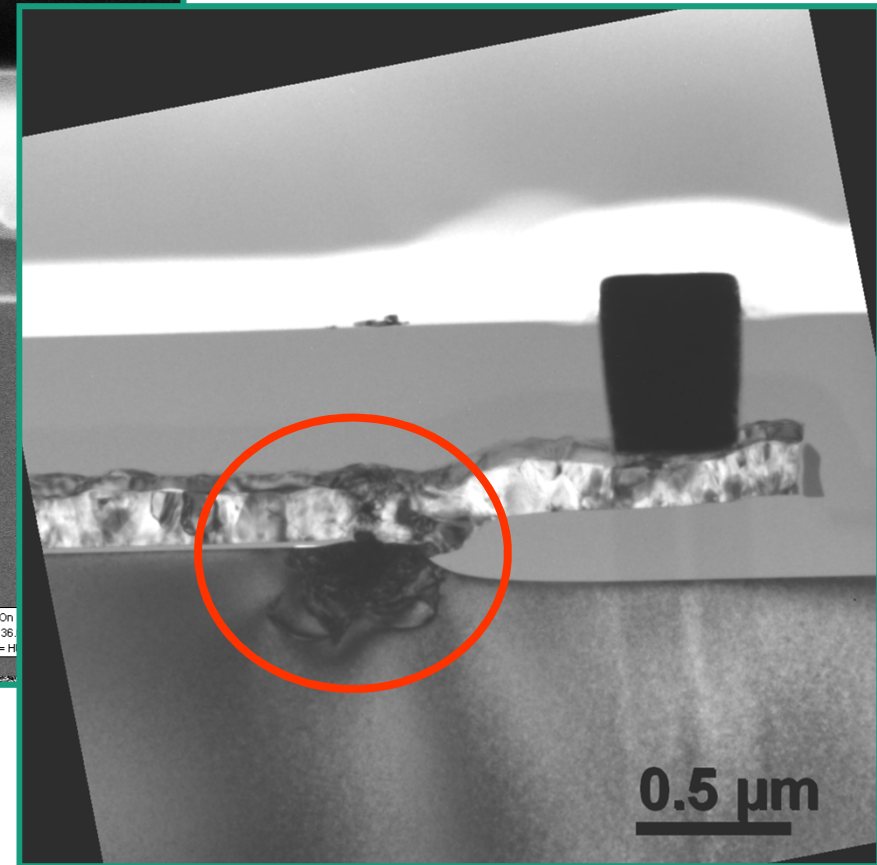
Root cause: oxide weakness at capacitor edge causes electrical breakthrough during operation

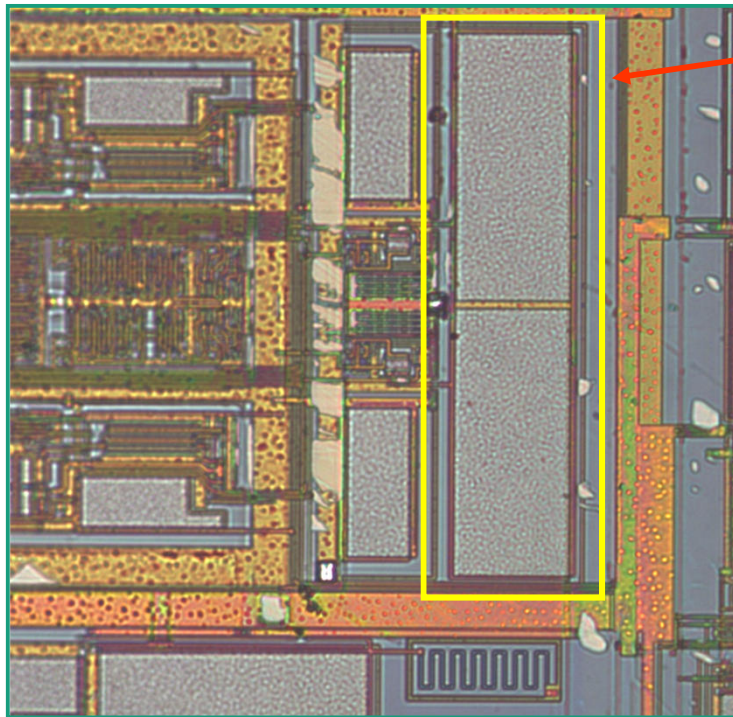
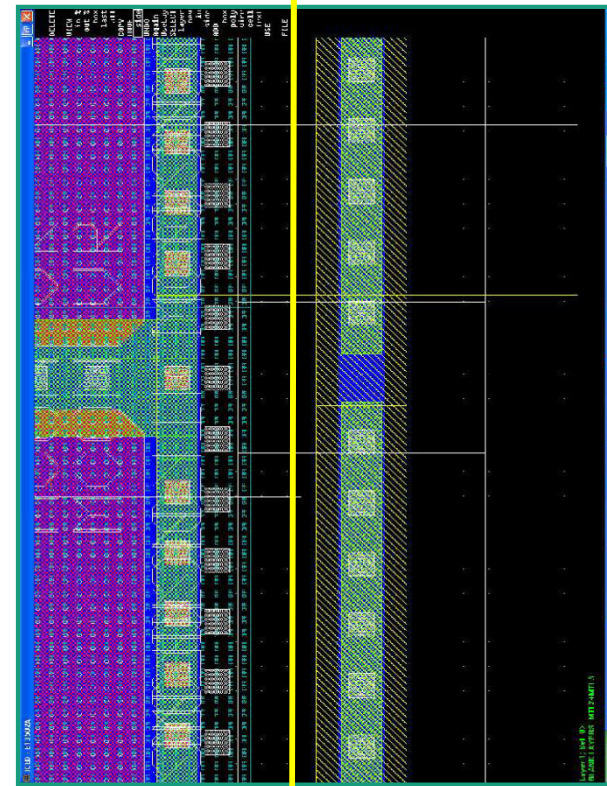
Position of the pn-junction surrounding the capacitor

- Large area capacitor shorted to ground possibly caused by short to guard ring
- PEM, OBIRCH analysis not successful
-> EBIC to visualise pn-junction

Grounded guard ring around the capacitor

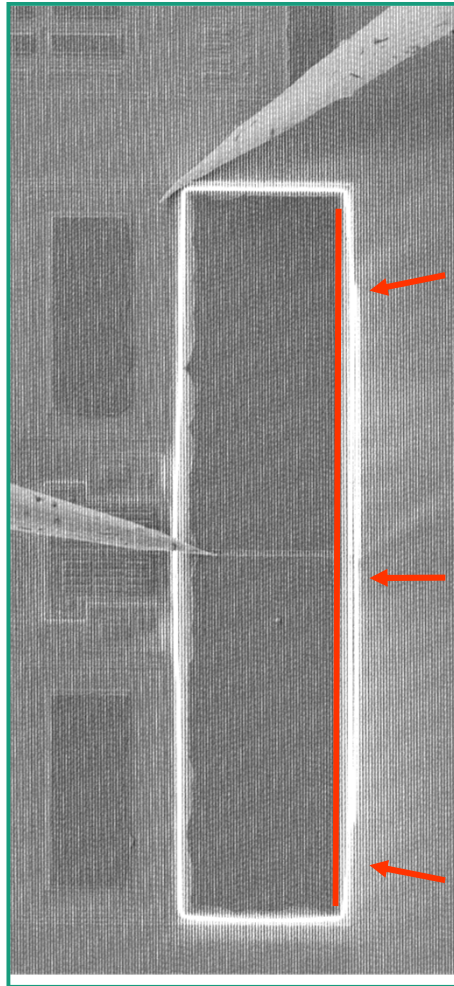
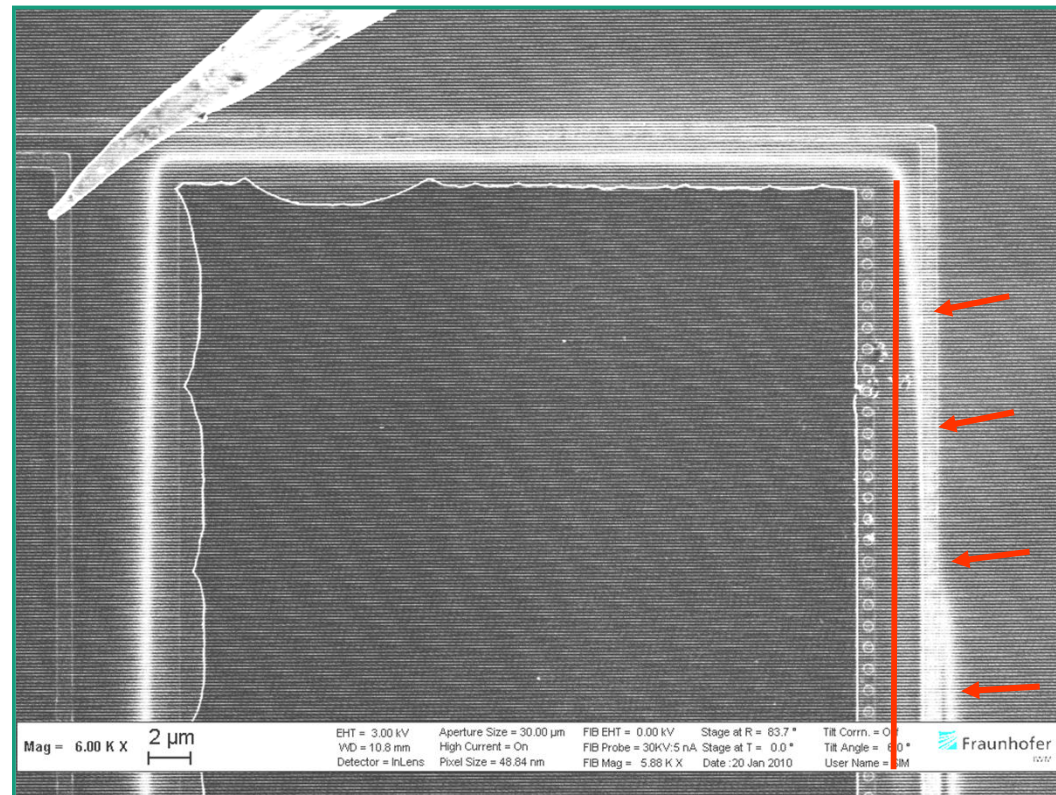
- Red line marks expected position of the pn-junction
- EBIC signal confirms shift of pn-junction to the guard ring structure

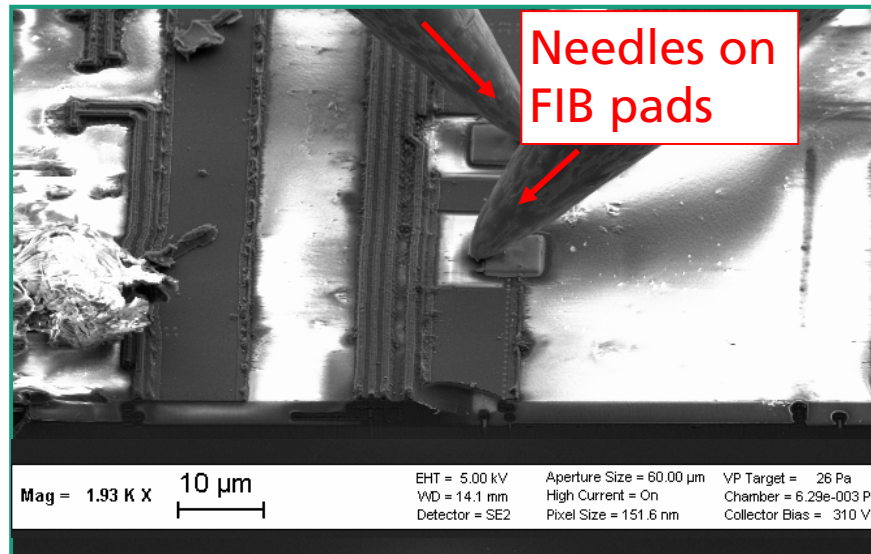
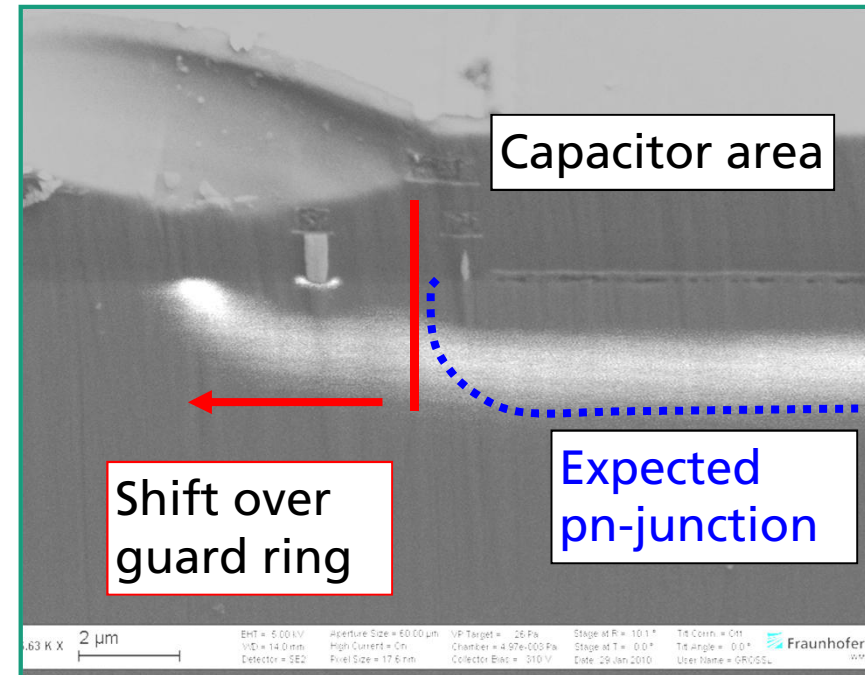
Root cause: shift of implantation mask is shortening n-doped guard ring with lower capacitor plate

- EBIC at mechanical cross section to verify pn-profile (second sample)
- FIB pads to probe doped areas of capacitor
- Results confirm shift of pn-junction over the guard ring
