Combined FIB/EBAC Methods for Failure Analysis on Integrated Circuits

European CrossBeam® User Meeting Stuttgart, 15/16th May 2012

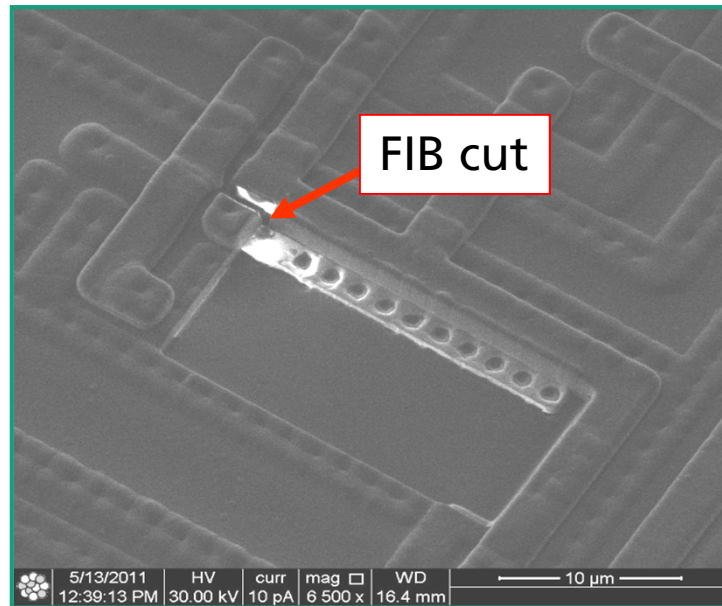
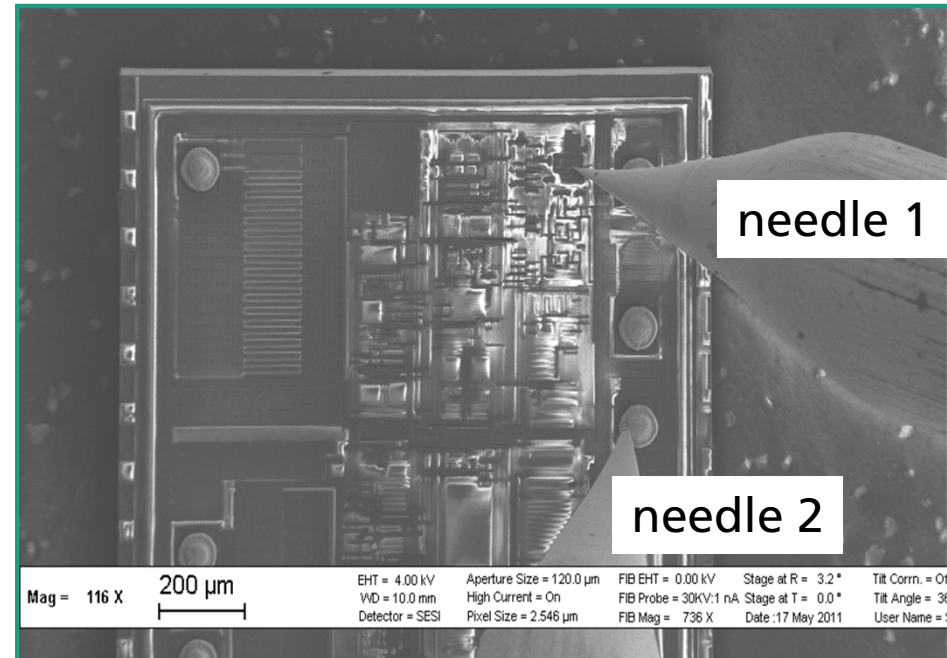
EBAC localisation of gate oxide breakdown

- Transistor gate shorted to substrate
 - Short localisation by PEM, but alignment to IC structure was insufficient for further TEM analysis
- > EBAC localisation

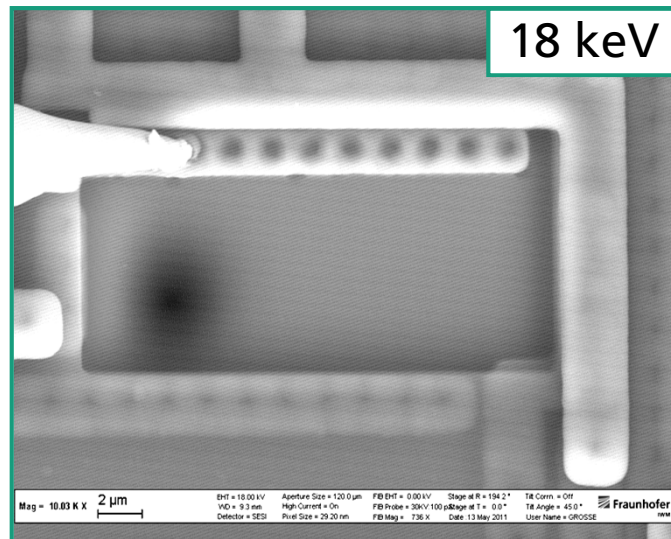
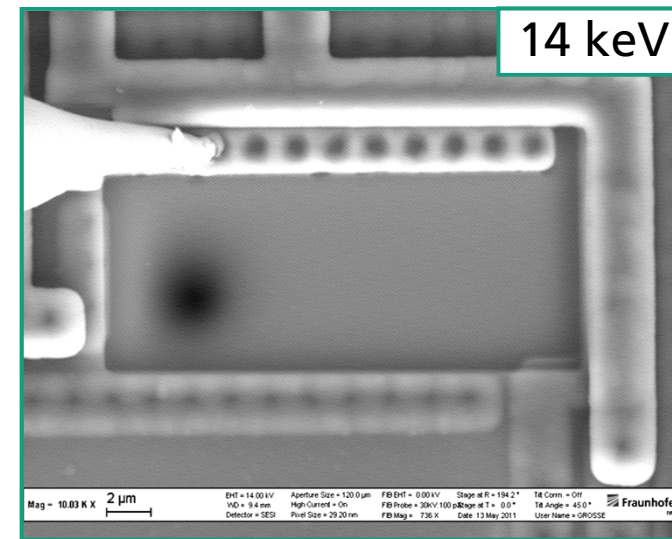
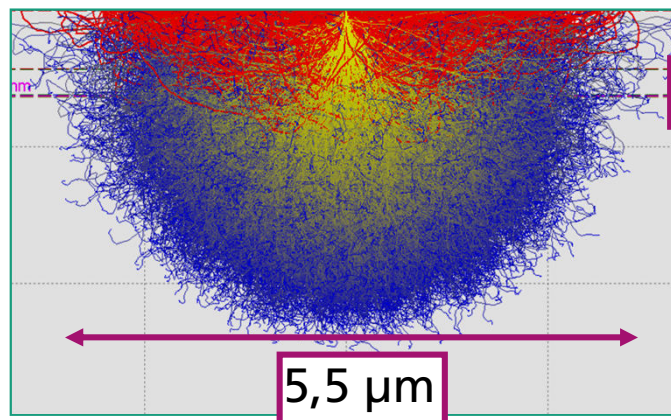
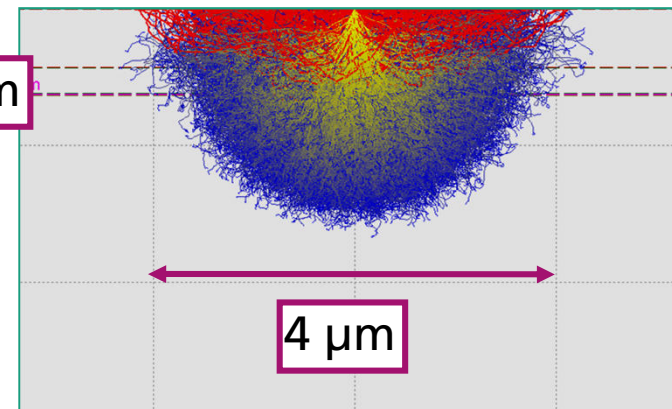
EBAC localisation of gate oxide breakdown

Stepwise reduction of primary energy to reduce interaction volume

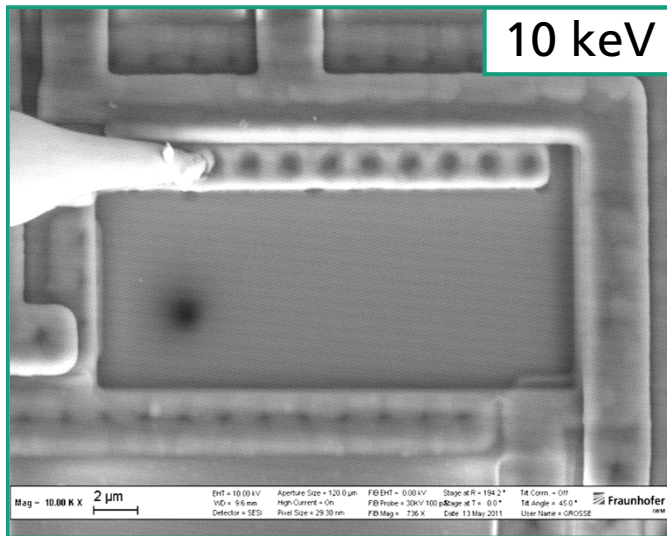
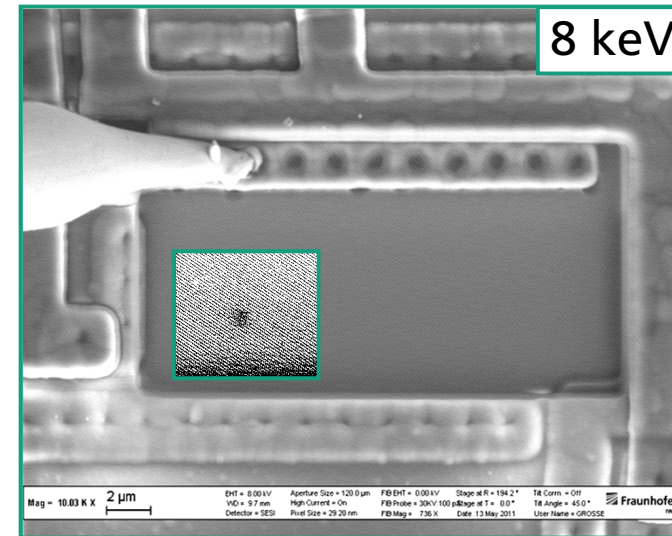
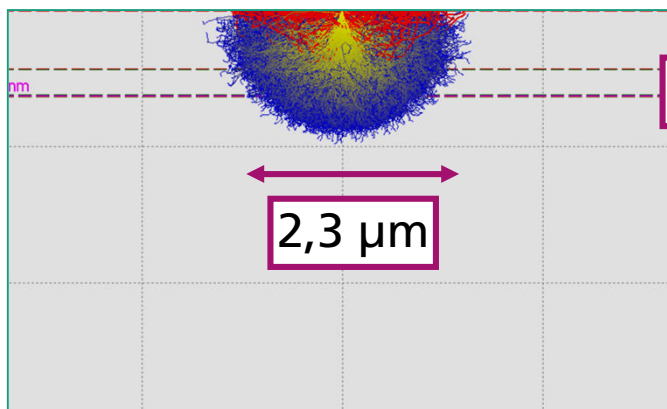
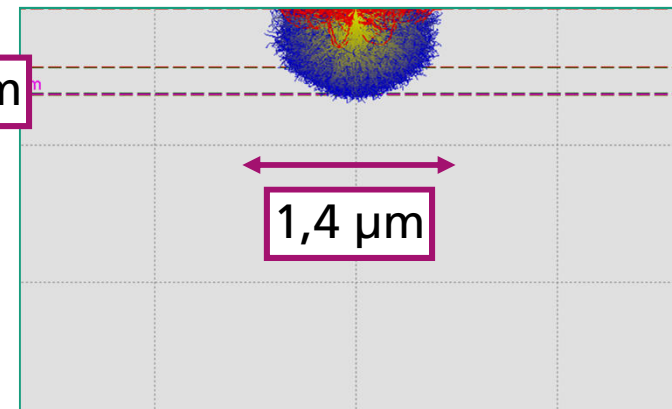
EBAC localisation of gate oxide breakdown

Stepwise reduction of primary energy to reduce interaction volume

Root cause: ESD damage of GOX

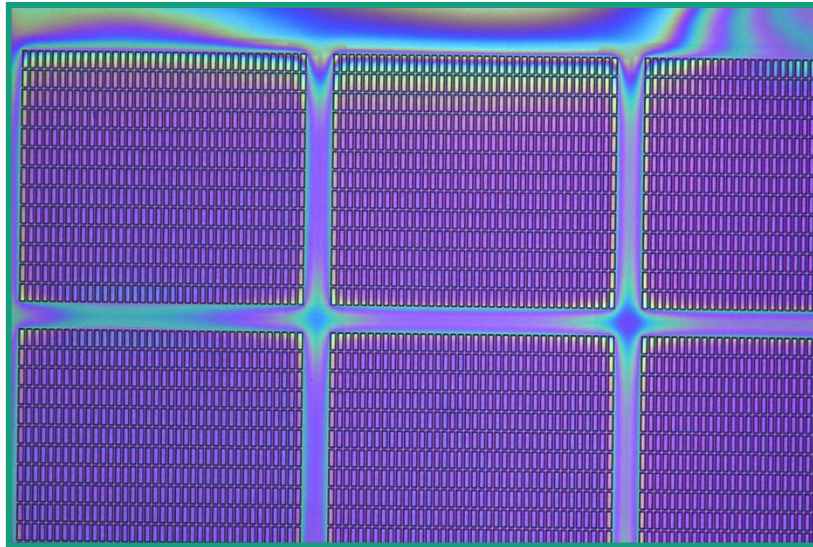
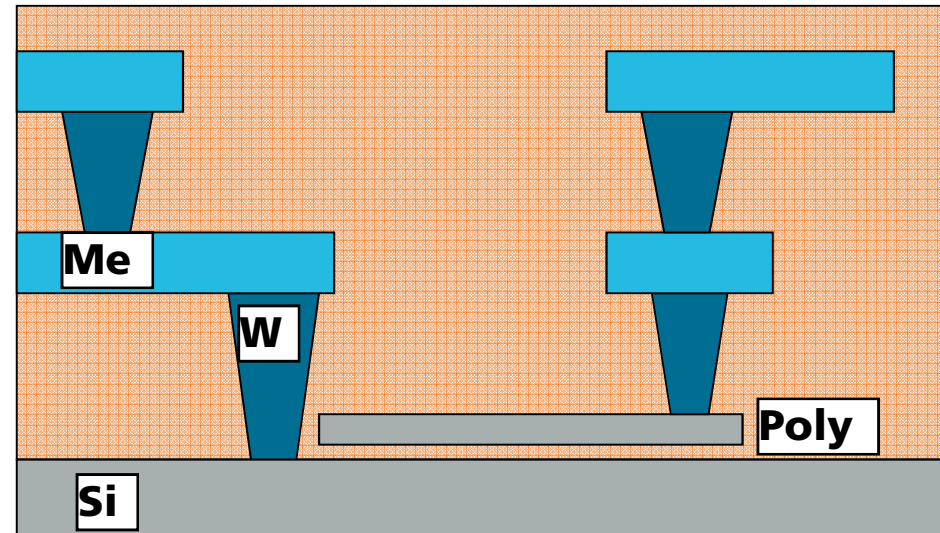
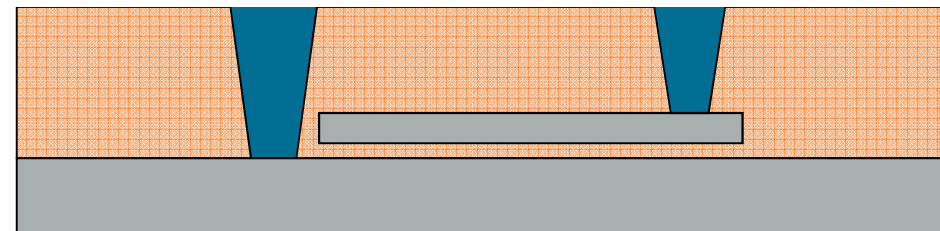
Mechanical delayering

- The whole capacitor has a leakage to the substrate
- Capacitor consists of 20 modules with 13 columns and 38 rows each, makes 9880 overall single capacitors
- How to localize the defect?

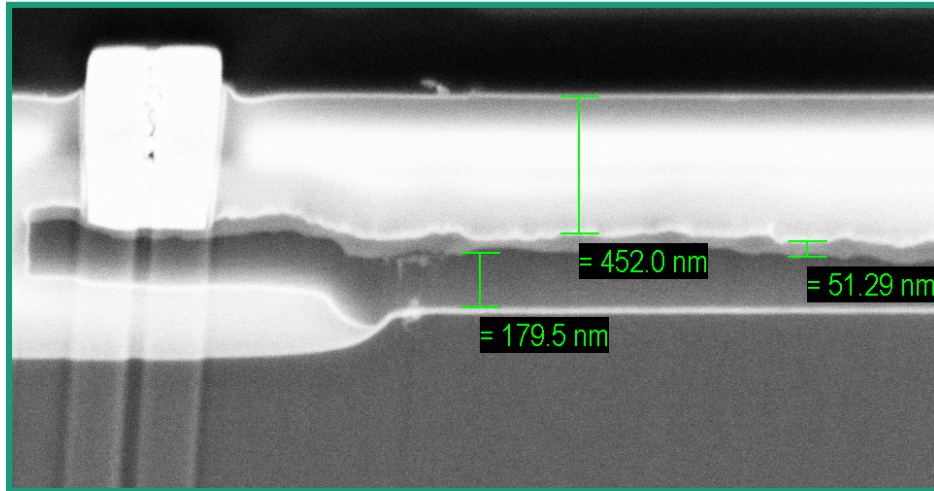
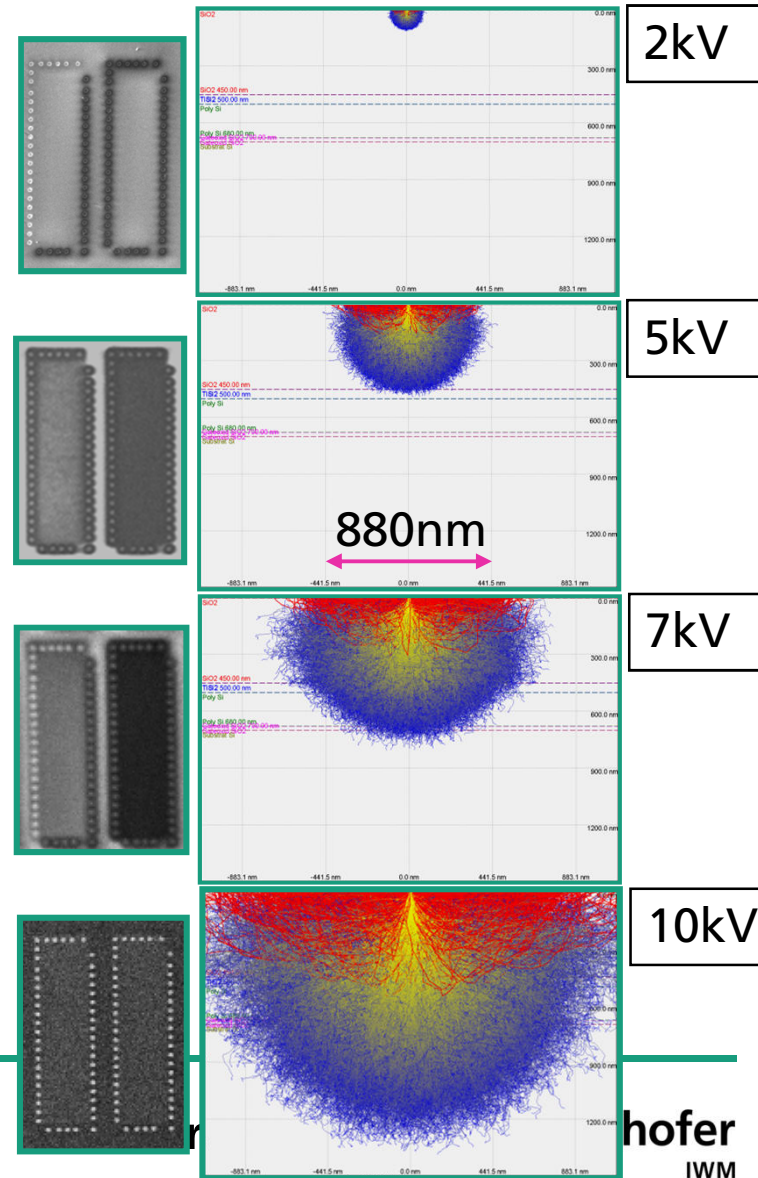
Passive voltage contrast imaging

- SEM voltage contrast depends on primary energy
- @7kV electrons reaches the poly plate -> faultless capacitor is floating (appears bright), shorted capacitor appears dark)

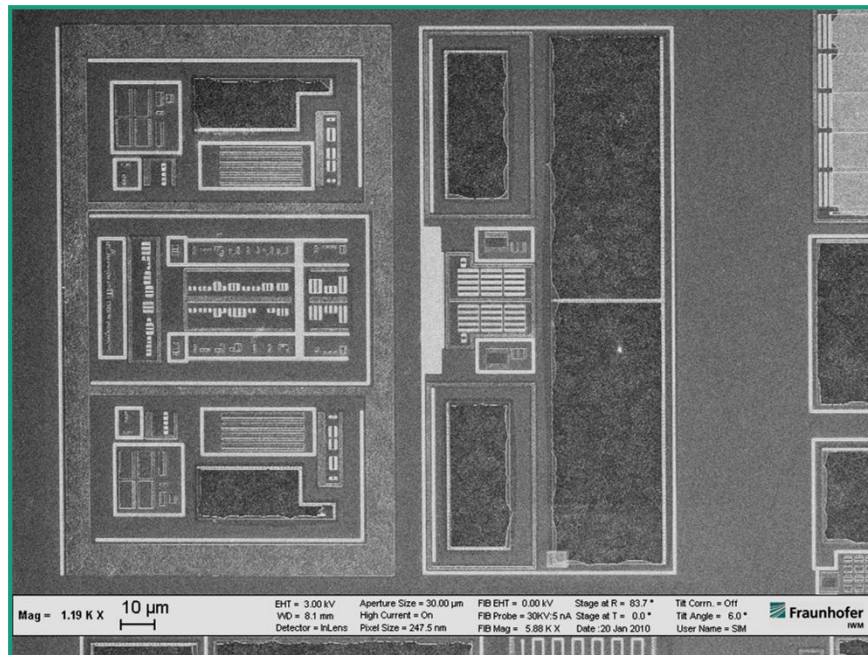
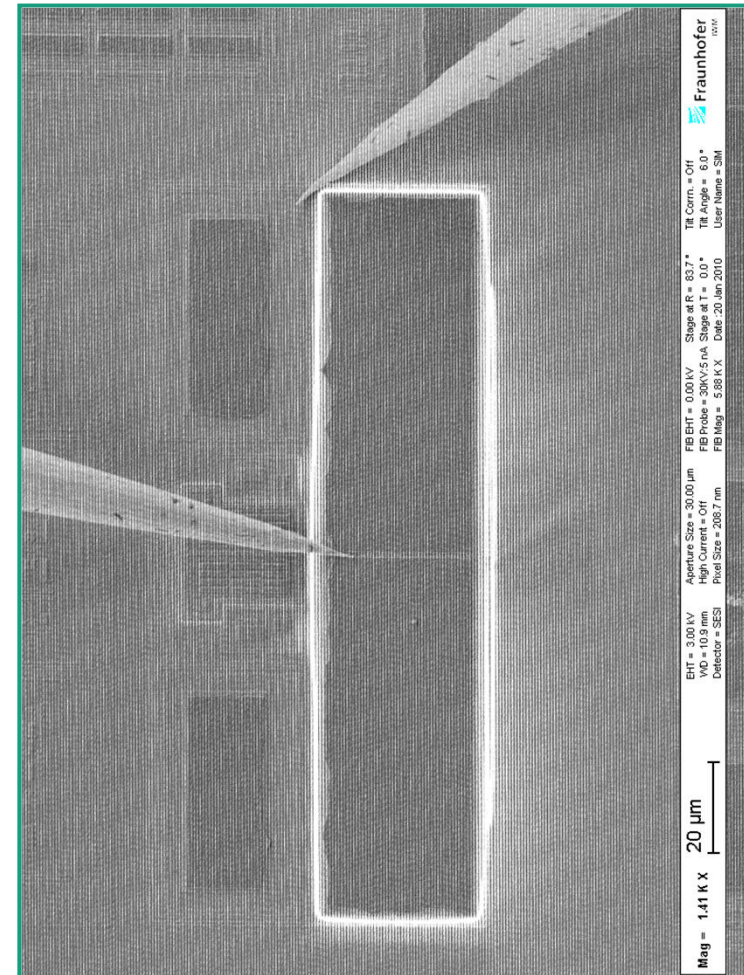
Top down EBIC to visualise pn-junction frame around capacitor

- Large area capacitor shorted to ground possibly caused by short to guard ring
- PEM, OBIRCH analysis not successful
-> EBIC to visualise pn-junction

Root cause: shift of implantation mask is shortening n-doped guard ring with lower capacitor plate
